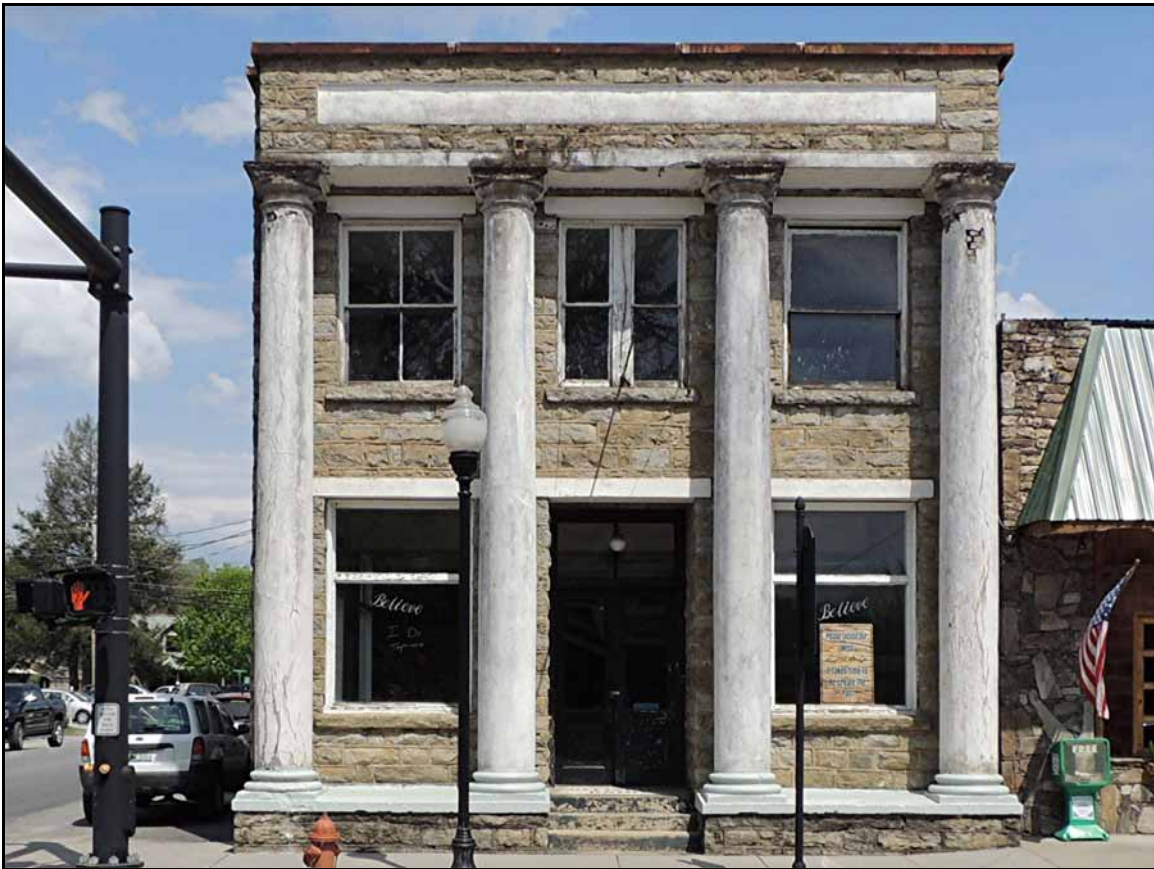
This building was the Bryson City, North Carolina bank. It is a stone building much in need of a cleaning and renovation. The front of the building faces west so it gets a lot of sun which helps keep the face of the stone clean. Note the mold and grime on the undersides of the tops of the columns.

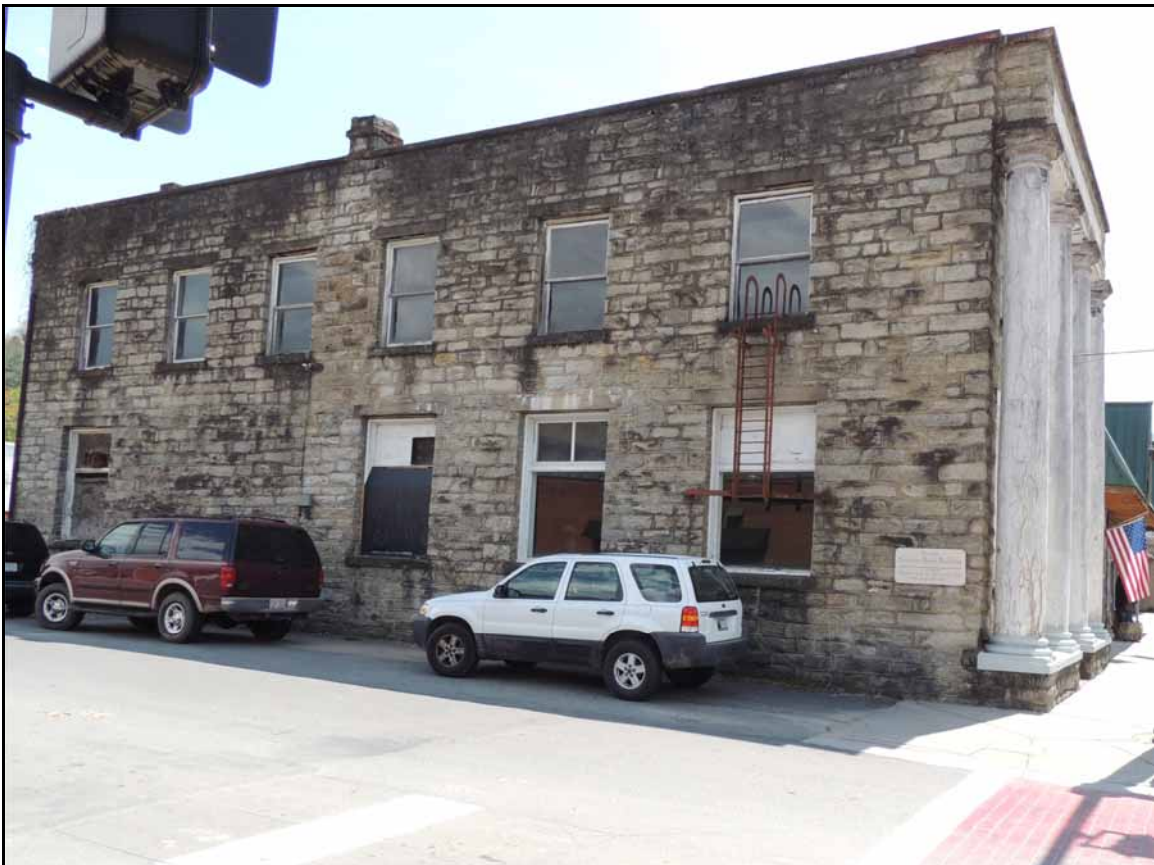
The side of the building, which does not get direct sunlight has a lot of mold and grime. It is interesting that the mold and grime is more towards the upper area of the building.

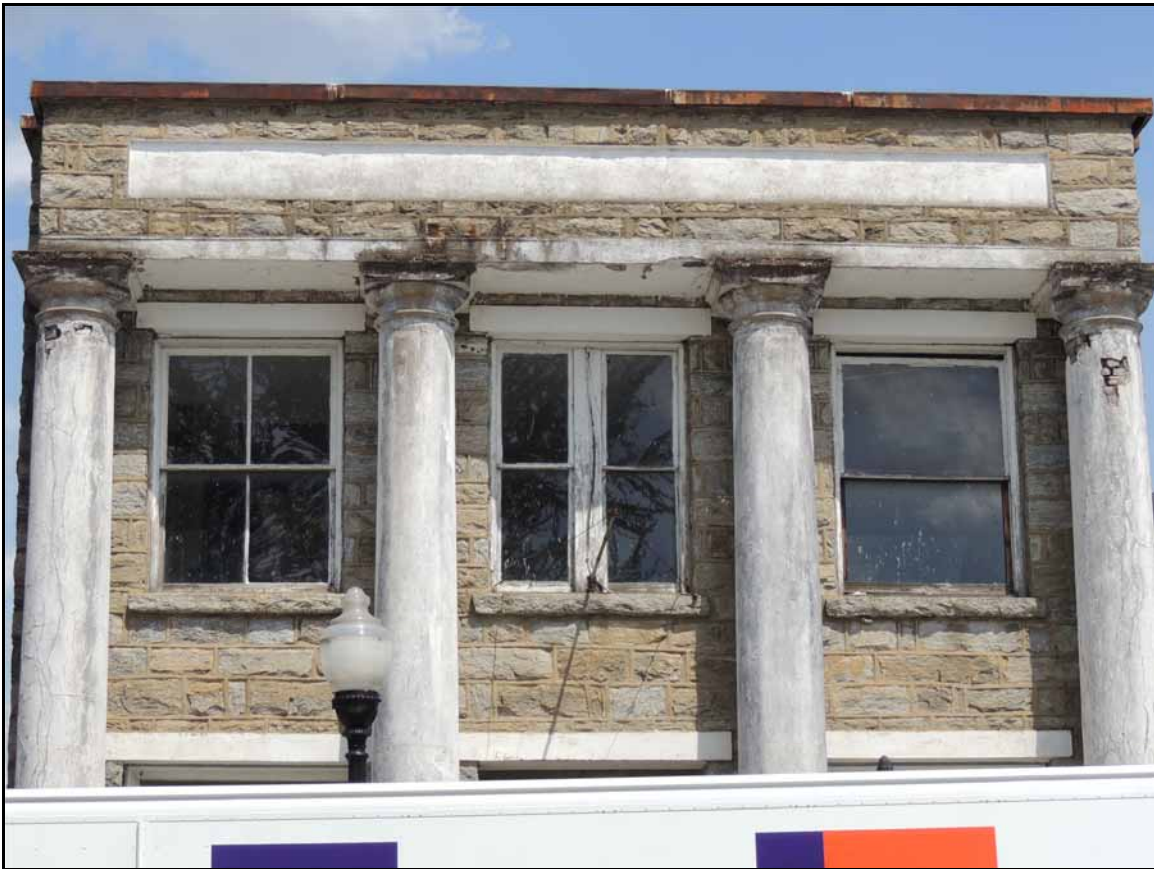
The two center columns look like solid stone, but the two outer columns, especially the one on the right tell a very different story.

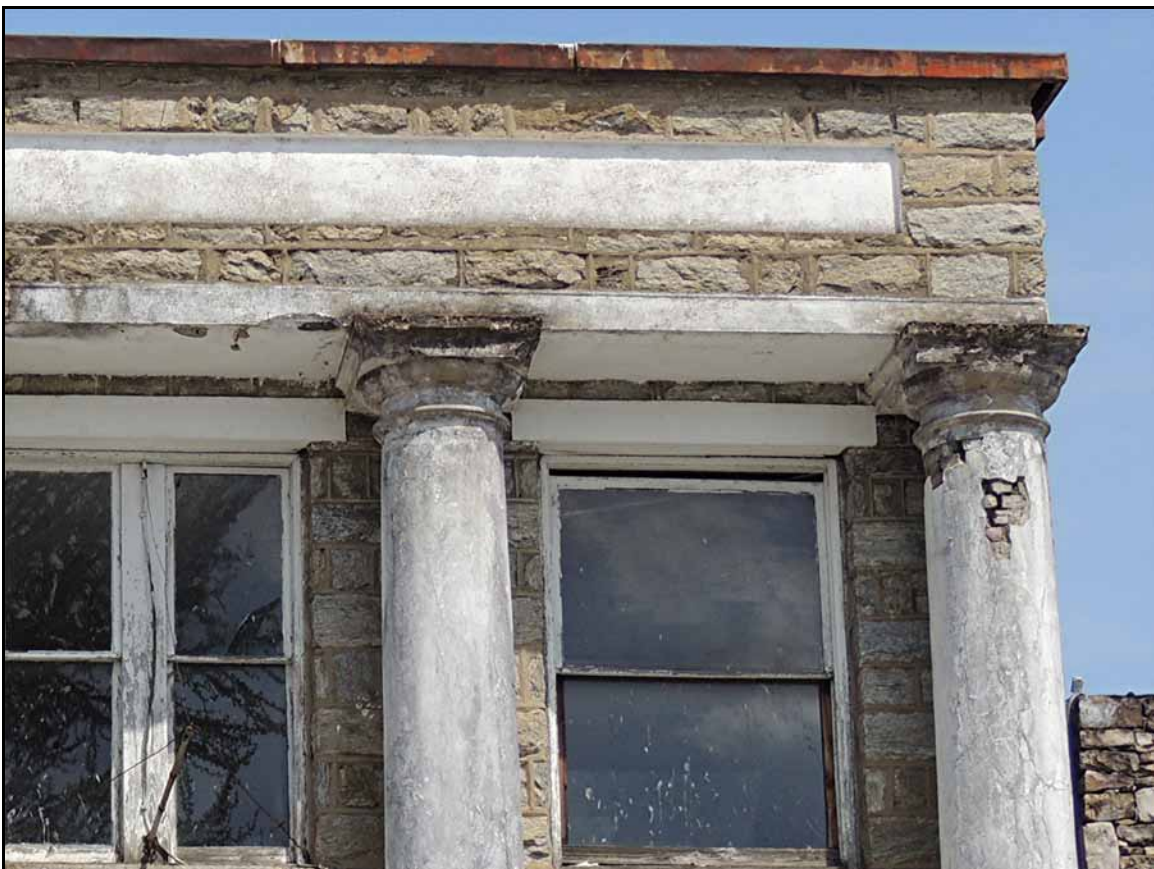
A closer inspection reveals that the columns are really brick with a mortar or some other type of covering. The column tops appear to be stone. Note how the paint on the windows is peeling from the bottom areas.
