The Trumpeter 1/350 scale German Battleship Bismarck is a complete kit which includes all the photoetch railings. The superstructure sides have a lot of surface detail and the deck scribing is well done. The fit is good except for a slight problem with the main deck which I show you how to fix. There is also an issue with the anti-aircraft gun right barrels. Overall this kit is a big step up from the Tamiya kit and it does not have the slide molding issues that the Revell kit has. The kit's packaging is outstanding and the instructions and color sheet are excellent.

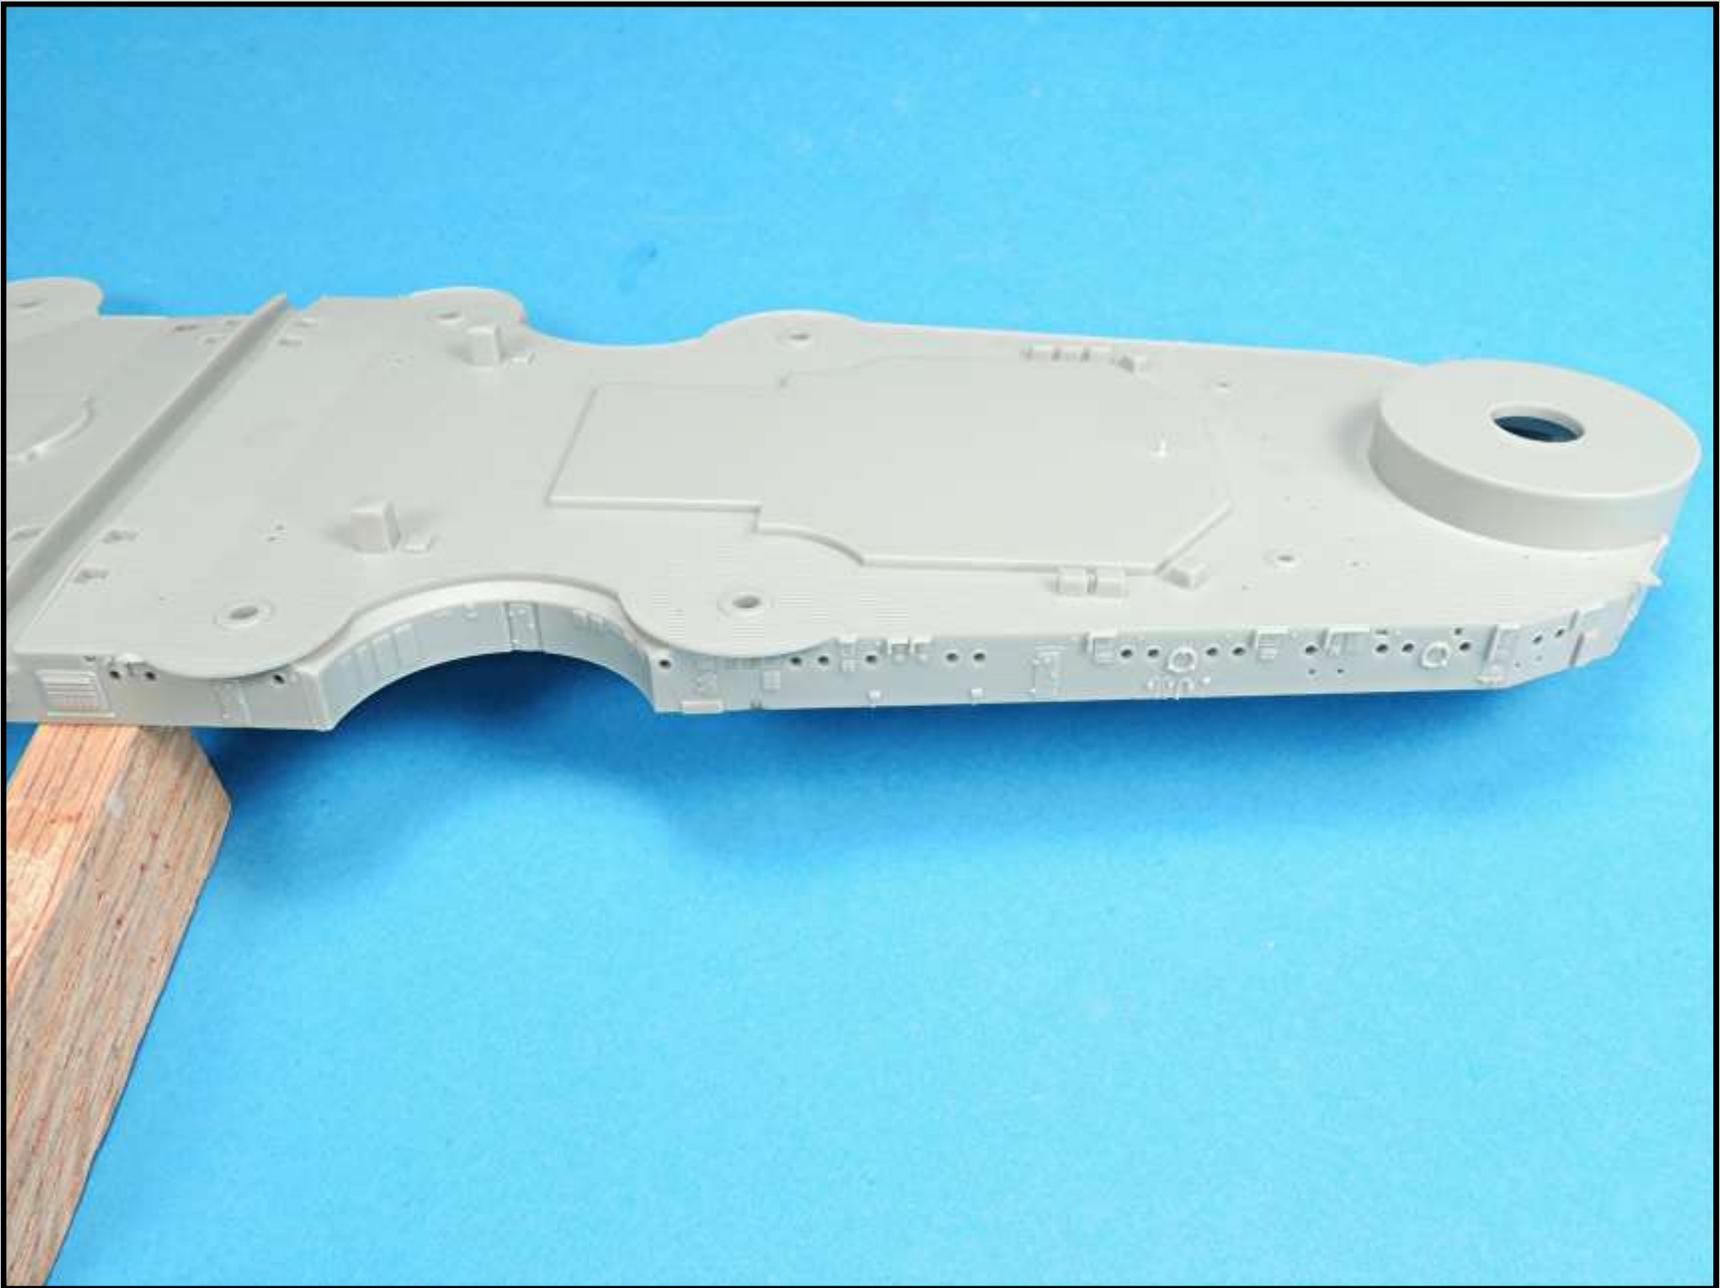
The surface detail on the superstructure sides is excellent.

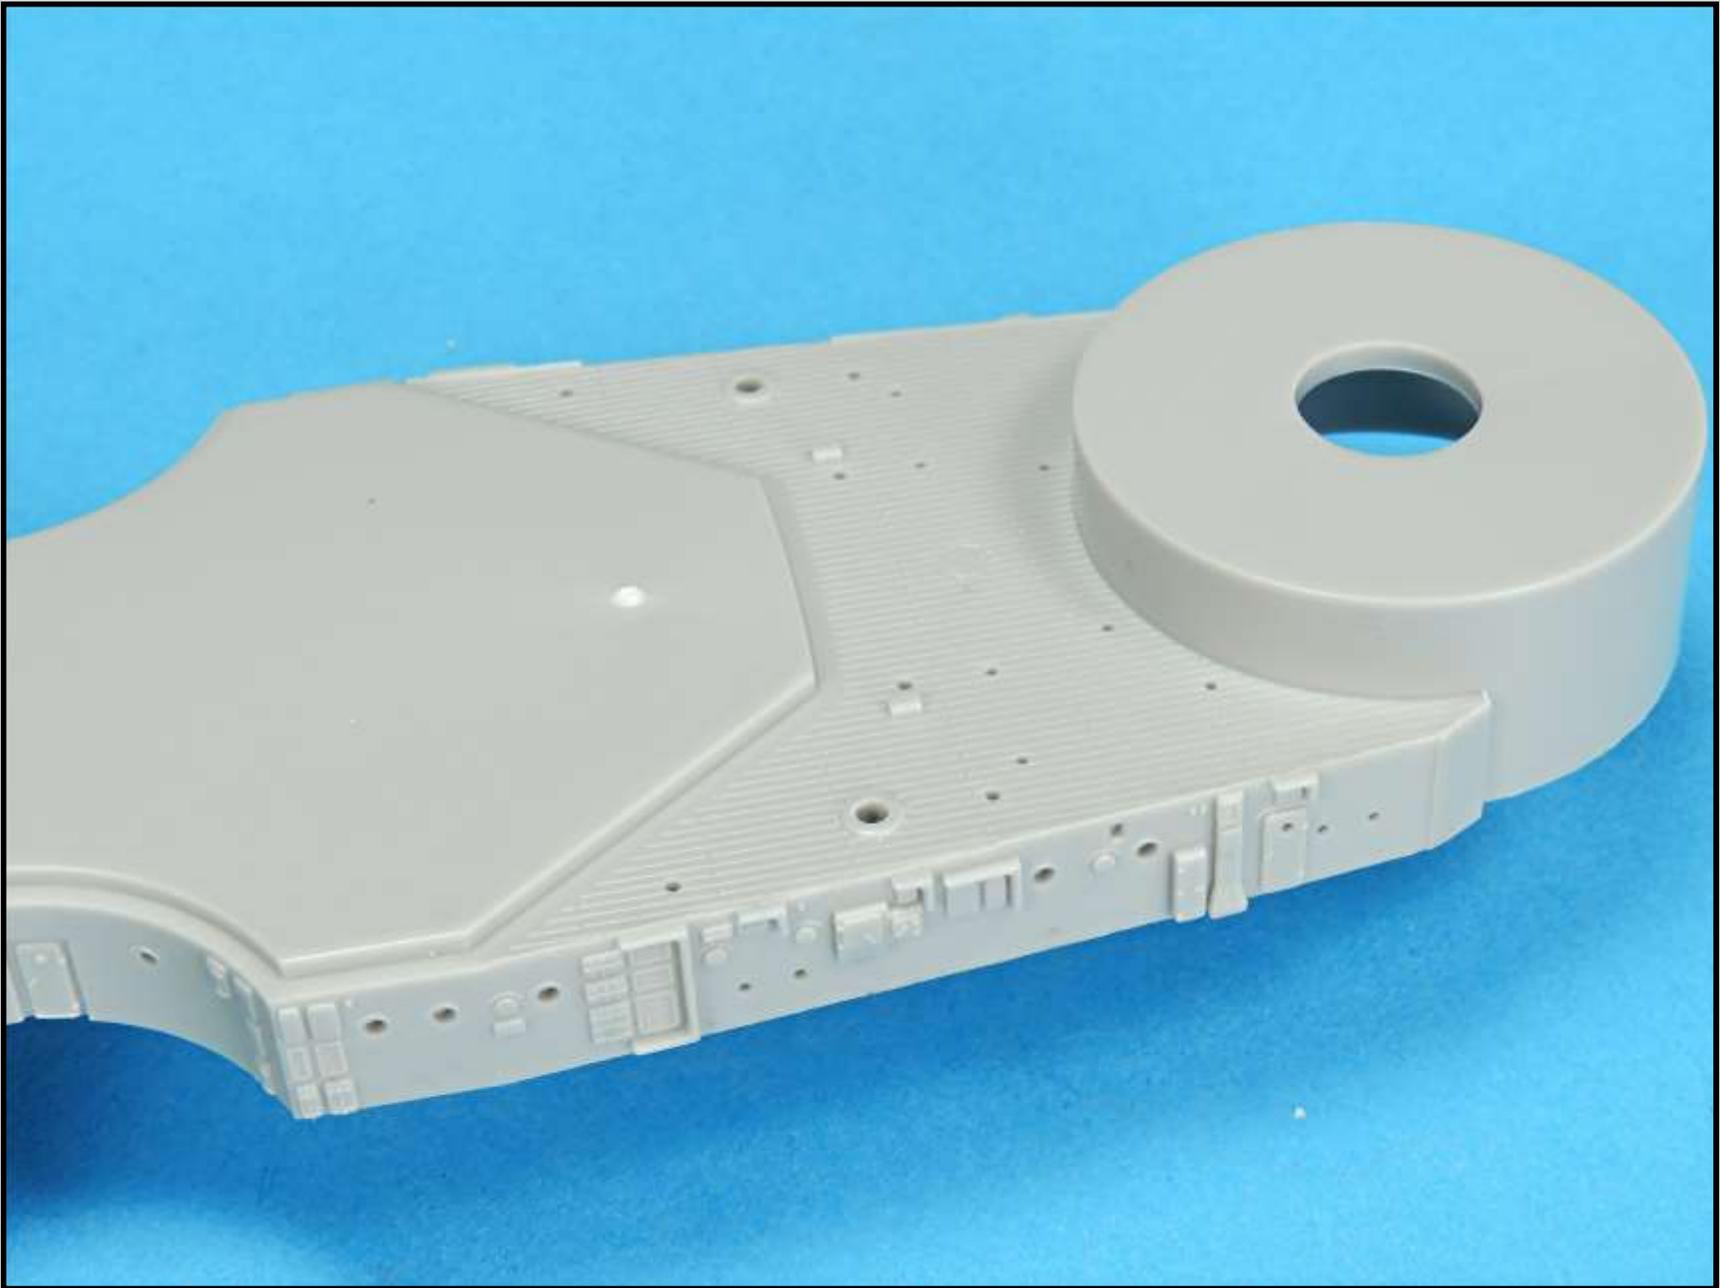
The wood deck scribing on the 01 superstructure deck is well executed just like on the main deck.

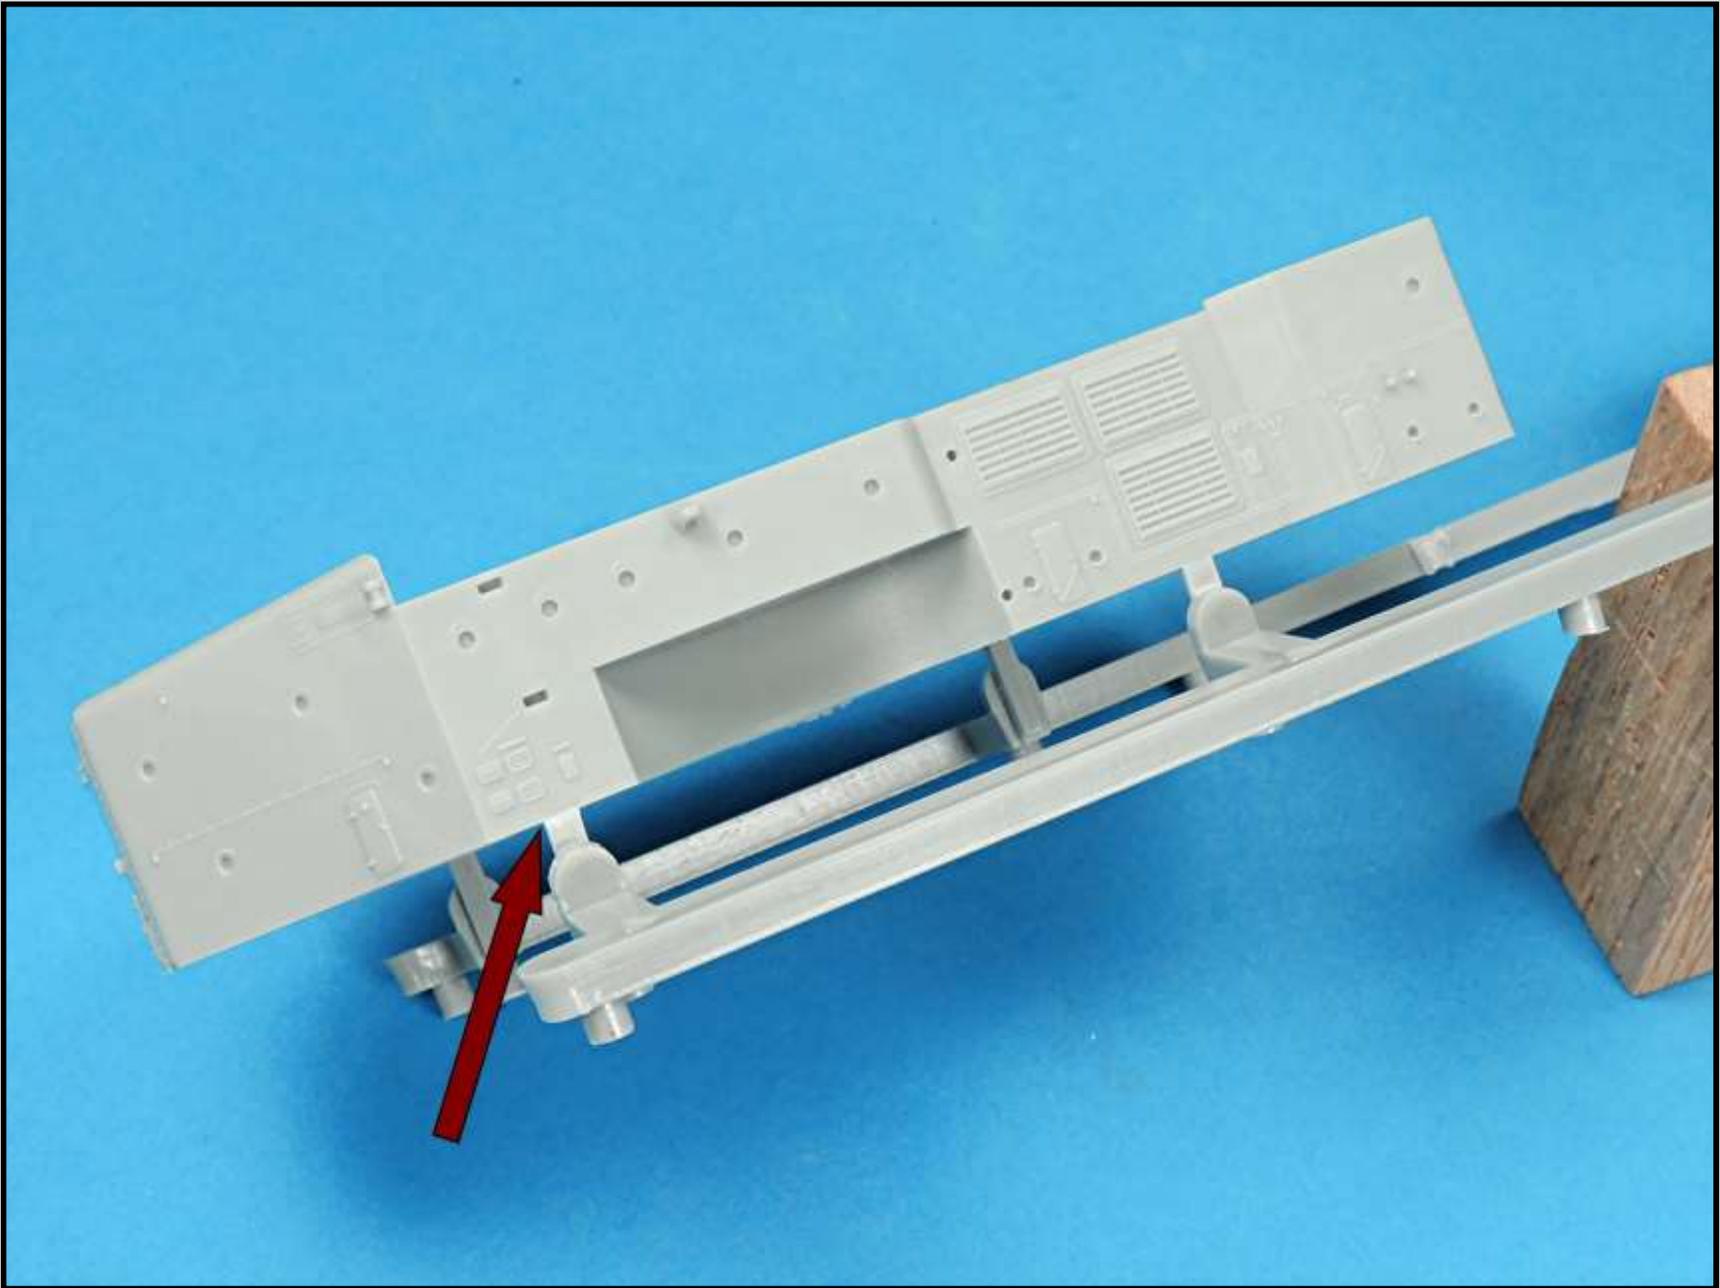
The tree attachment points on many of the parts are in locations that will not impact the part or they are in places where the surface detail will not be damaged when the tree attachments are removed and the surfaces cleaned up.

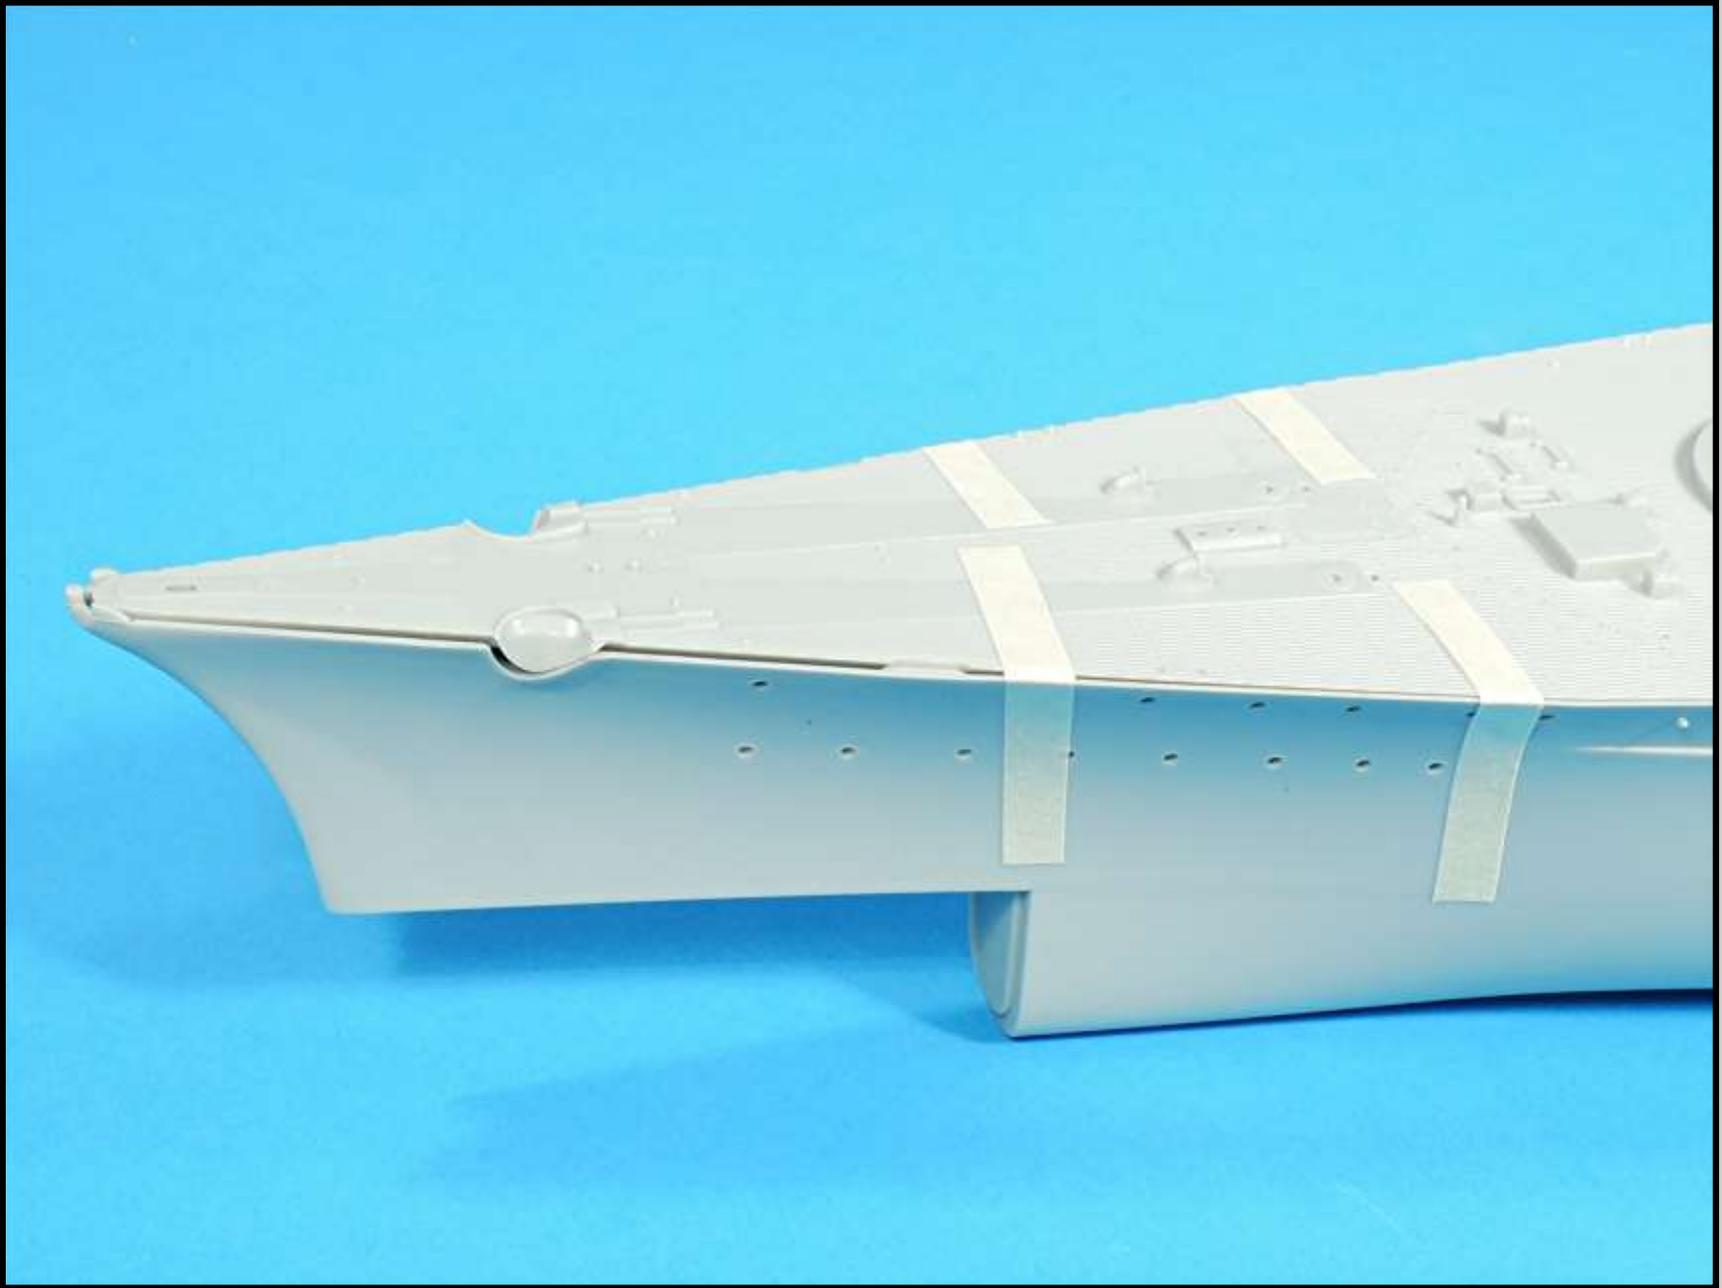
The main deck will not sit snugly onto the hull at the bow.

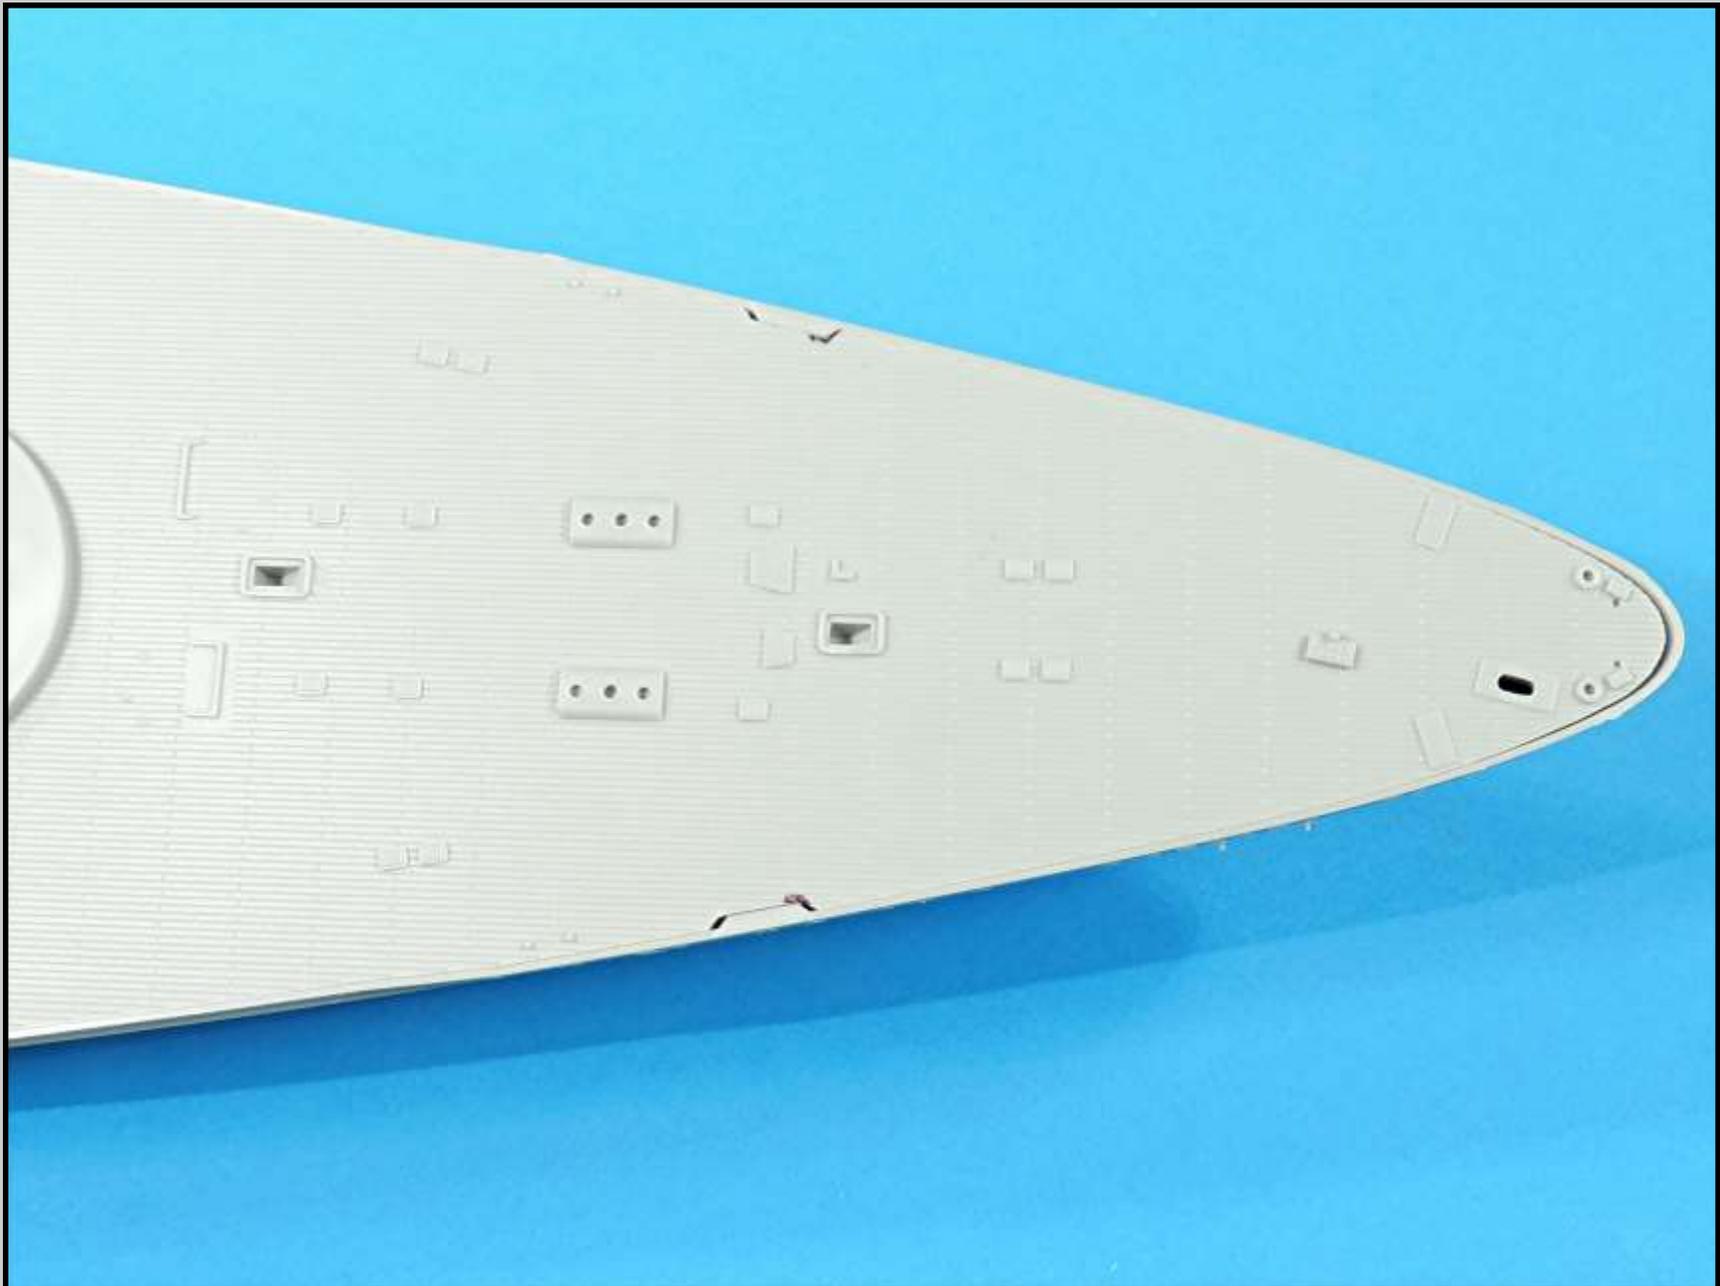
To fix this misalignment issue notch out the aft end of each of the deck cutouts. Remove a tiny bit of plastic at a time and form fit the deck into place. The tiny voids at the stern and at the two cutouts can easily be filled with either super glue or white glue.

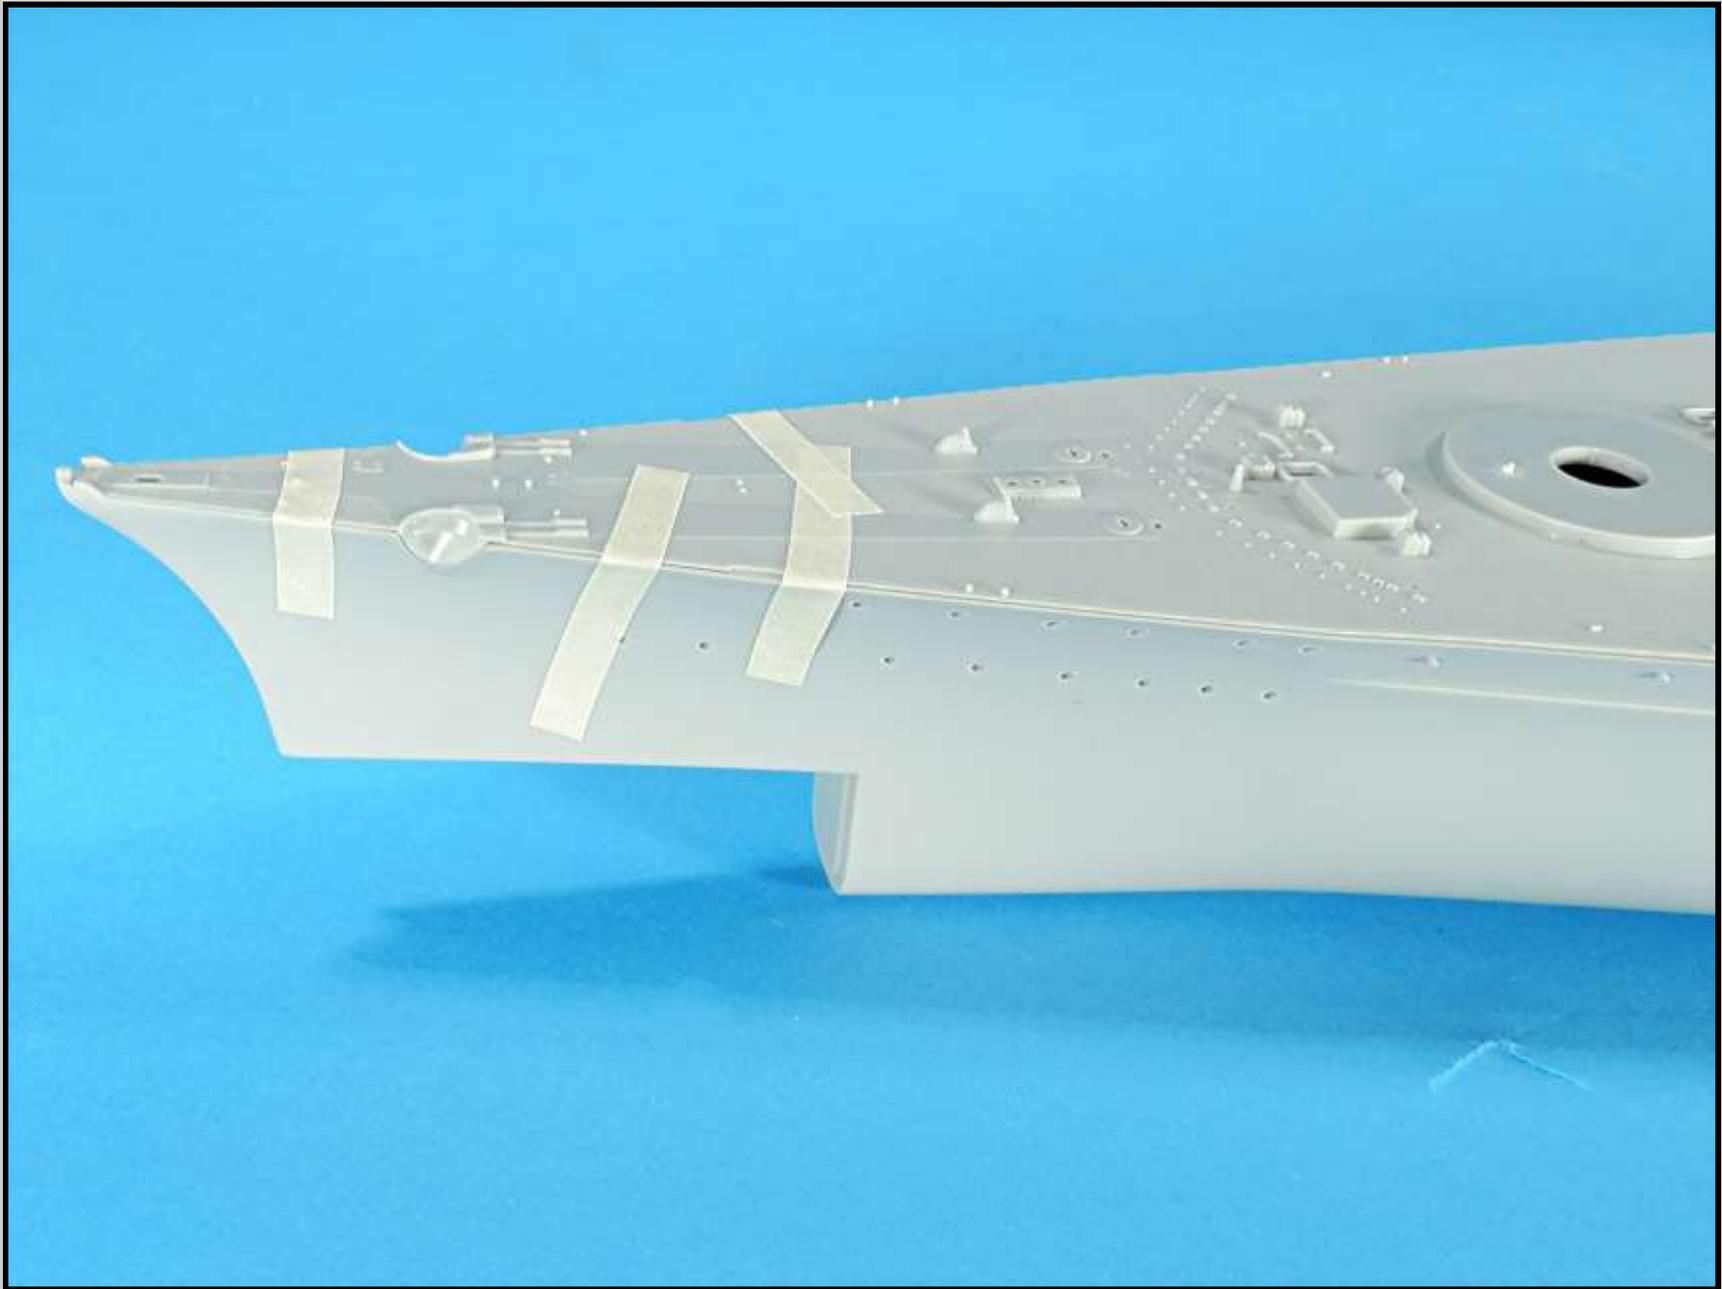
With the stern area fixed, the main deck fit at the bow is greatly improved.

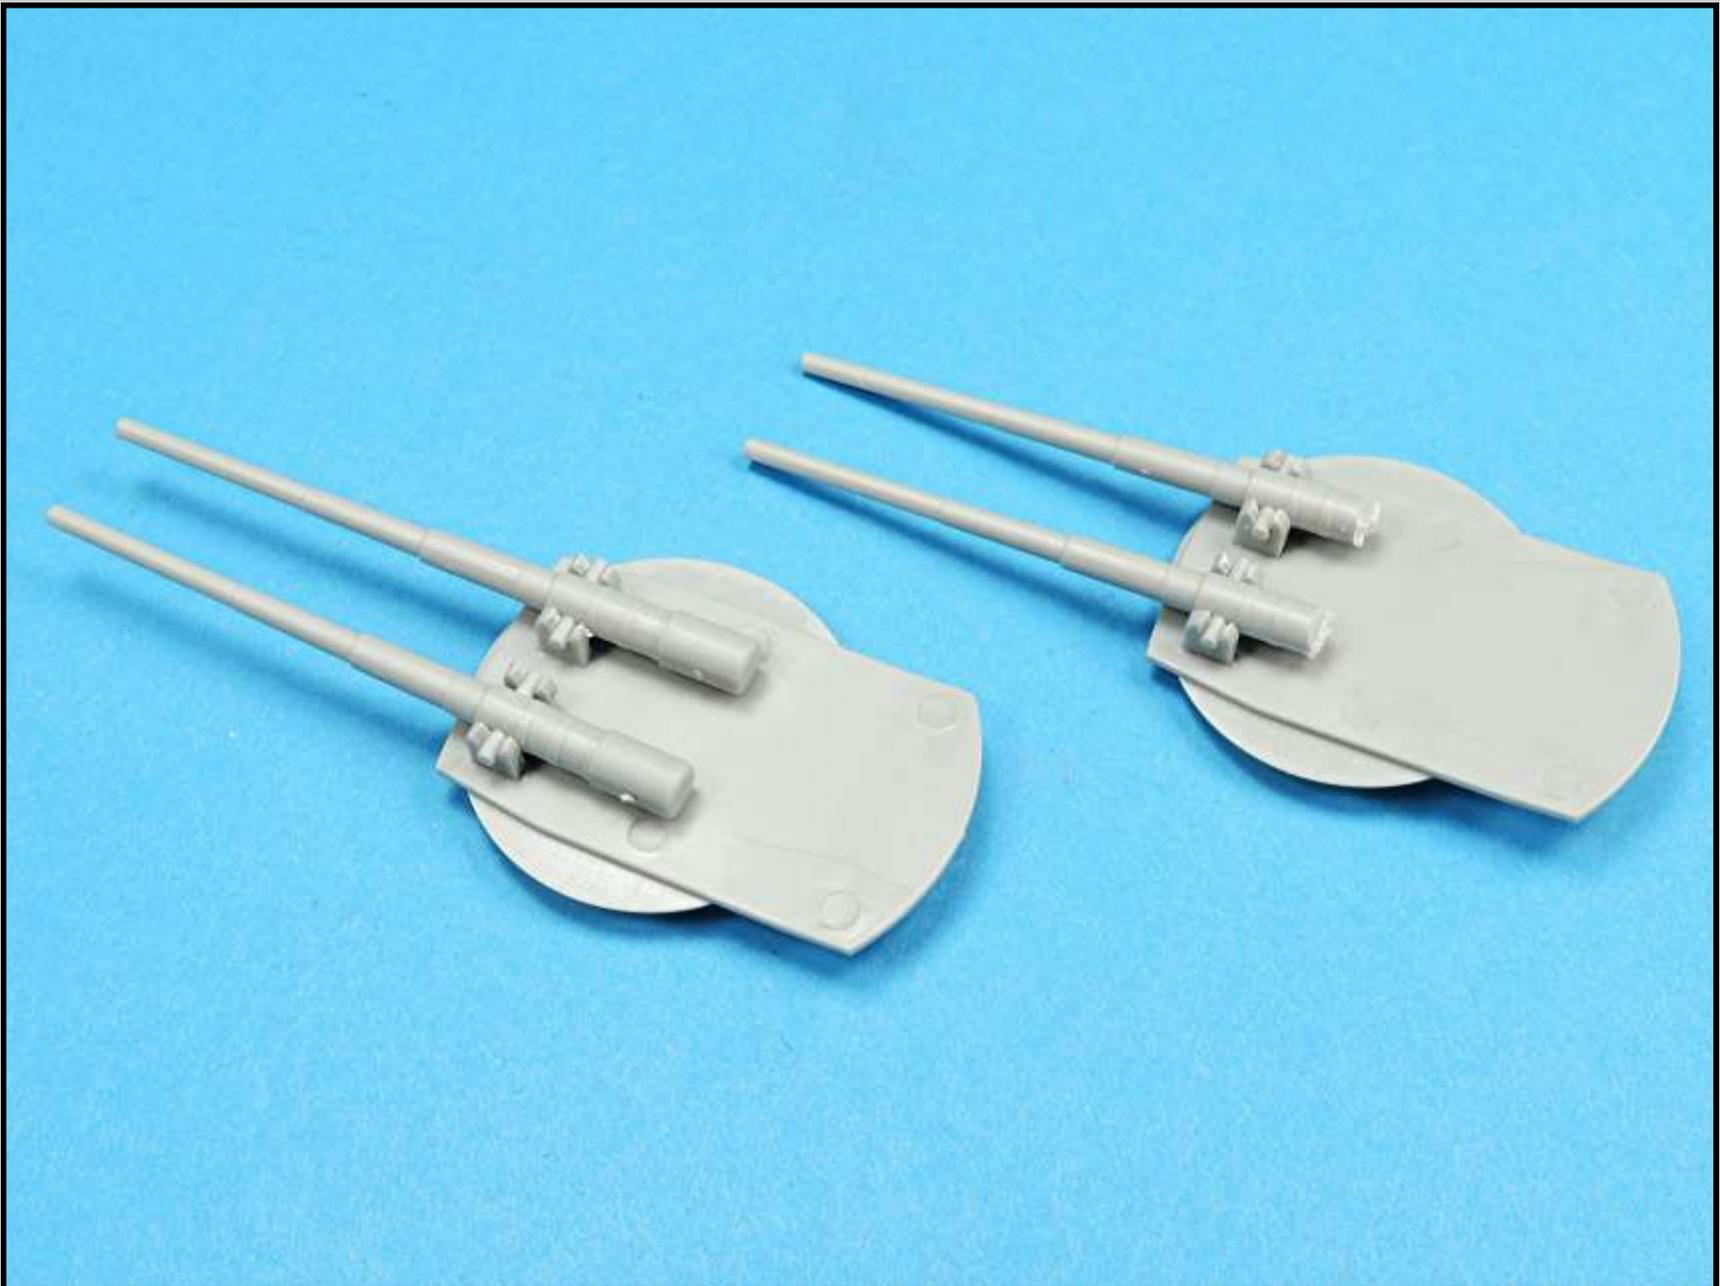
To elevate the main guns, cut off the ends. I also cut off the tops of the gun barrel positioning rings so that the guns could be snapped into place after painting them and the turrets separately.

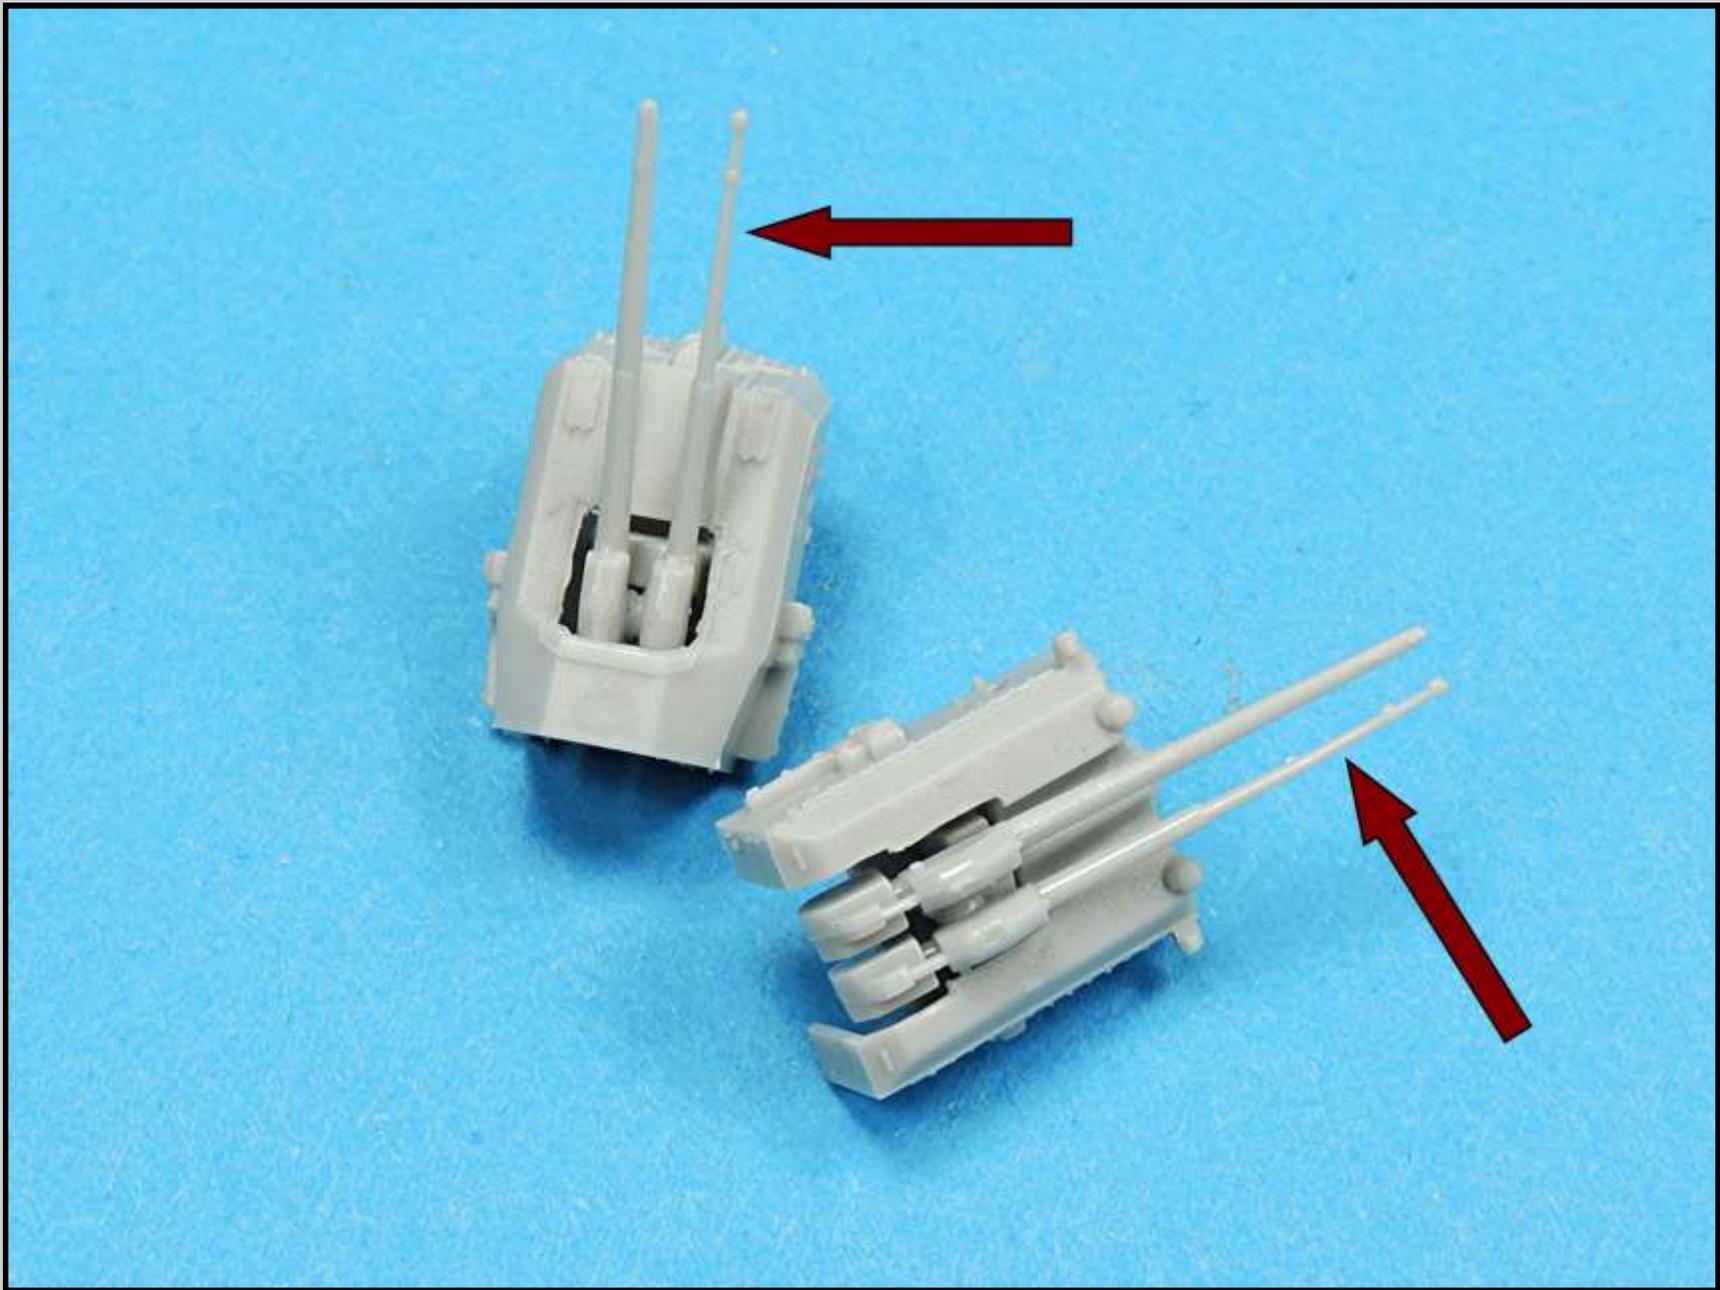
The right anti-aircraft barrels are badly deformed. I recommend replacing the entire assemblies with parts from a Tamiya Bismarck kit, resin detail sets or 3D printed sets.
